An E-mail from the Richter family working in Burkina Faso with FIA, January 2010

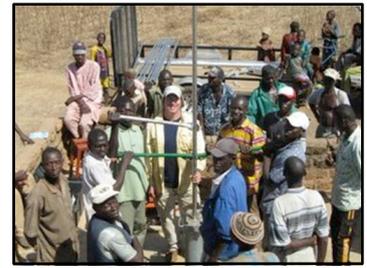
After greeting village leaders and praying together for God's blessing that we could get this well fixed, we began pulling out the old broken pump a little after 9am. Church leaders from various villages had arrived and we quickly put them to work learning the various jobs needed to do the repair. So, we were repairing the well as well as doing on the job training. Somewhere around 11:30am the old rusty pipes were out of the hole. It wasn't hard to see the problem; several pipes had holes pierced in them from rust, and the foot valve was clogged up with lots of chunks of rust.

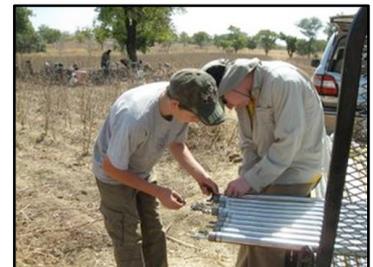
Matt then measured the water level and well depth, which turned out to be very encouraging. There was a lot of water down there, good water. The static water level was at 12 metres and the well depth was 36 metres.

After inserting a submersible pump powered by a generator, we were pumping water out of the well at better than 1 litre/second. To our surprise the water recharge rate was great; after an initial draw down and pumping for an entire hour, the water level only went down 12 cm! Matt roughly calculated a water volume production rate of 5 cubic meters per hour. Praise the Lord! It sure was a good feeling to know there was water in the hole, and plenty of it before installing all the new materials.

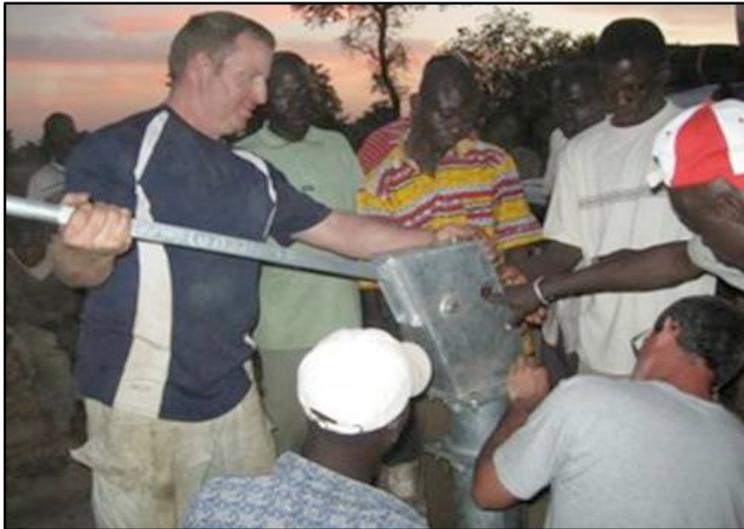
After a short break we were back at the wellhead installing the new stainless steel piston and pipes for the India Mark II pump unit. It took a little while for everyone to get into the routine, but soon the pipes were coming and we had a good system going. We ended up only having to install 10 pipes for a working depth of 30 meters trying to remember that the worst of the dry season is yet to come. When we got to the last pipe and were ready to put on the pump head, the pump rod was too long. No problem, just cut the rod and rethread it, right? Stainless steel is very tough and we couldn't get the threader tool started. Now, we didn't know what to do. Replace the last rod and try again?

We called one of our supply contacts that said we needed to pull the entire system and tighten the stainless pump rods all the way on the threads to reduce the length above. So, a little reluctantly, we started pulling the entire well again, unloosening the pipe and tightening the pump rods more fully, reapplying the horsehair joint material and connecting. However, when we finally finished with that proposition we still had the same problem! The pump rod was too long!

Another call revealed that the pipe man had forgotten to give me a special piece to account for the difference in length. Now, we were faced at possibly not being able to complete the

Like we had done many times already, we stopped to pray and ask for God's blessing and guidance. Despite my feelings of desperation, God was still at work inspiring one of our volunteers with another solution. The solution was to use a pump rod that still had the threads on it, which made it possible to start the threading tool and thread the rod all the
